FLIGHT MEASUREMENTS OF THE FLYING QUALITIES

OF AN F6F-3 AIRPLANE (BUAER NO. 04776)

II - LATERAL AND DIRECTIONAL STABILITY AND CONTROL

MEMORANDUM REPORT

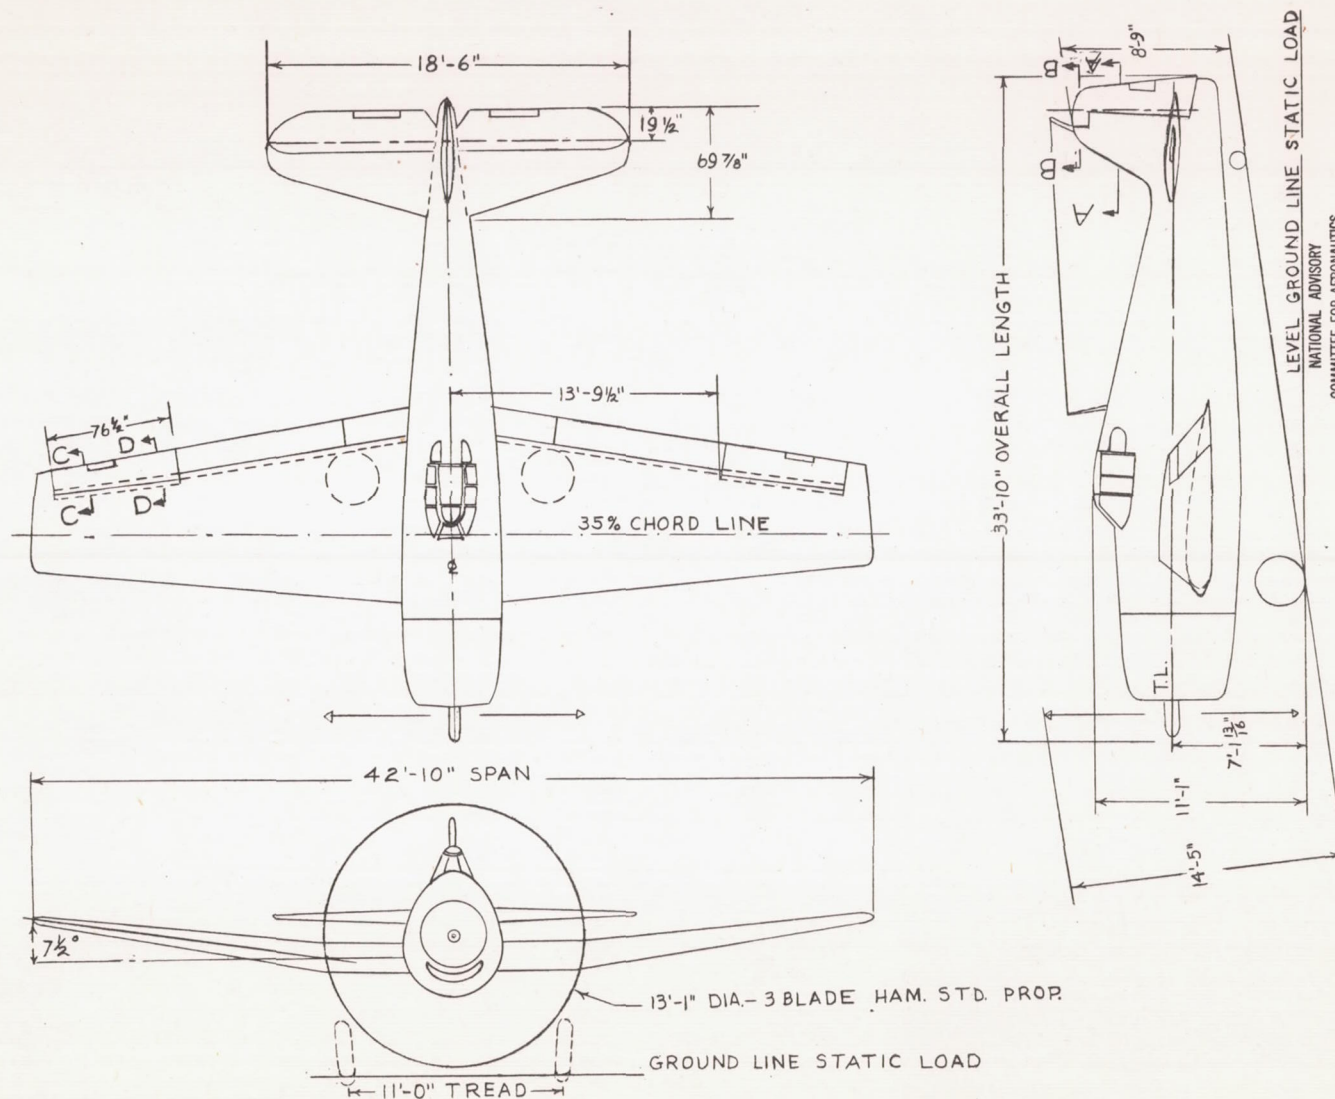
Figure 1. - Three-view layout of the F6F-3 airplane.

A three-view layout of the F6F-3 airplane is shown in figure 1. Pertinent details and dimensions of the F6F-3 airplane are given in reference 1. The relation between control-surface deflection and stick and rudder pedal position is shown in figure 2 for the rudder and aileron controls. Rudder angles are measured in degrees from the fin and aileron angles are referenced to neutral. Trim-tab angles are given in degrees from the control surface. Sections of the rudder are given in figure 3. Figure 4 gives aileron sections. Section letters on figures 3 and 4 correspond to the sections shown on figure 1. The products of the span and chord squared, on

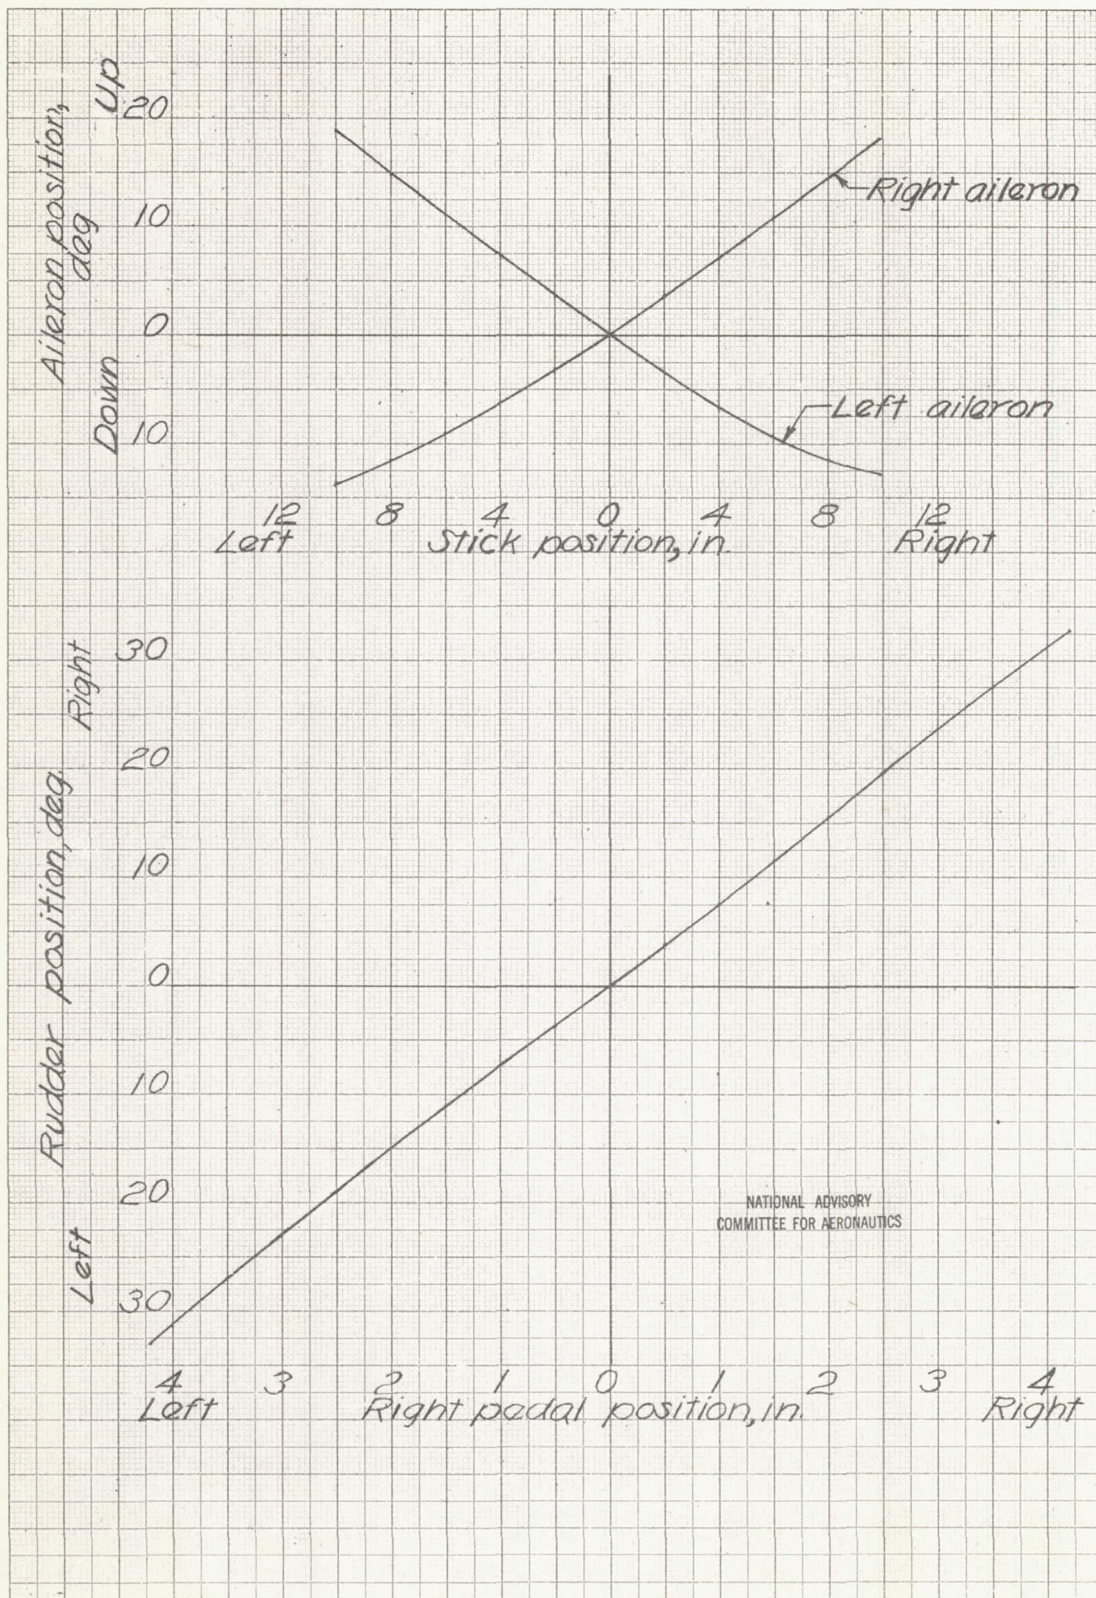
Figure 2. - Variation of control-surface deflection with stick and rudder pedal position. F6F-3 airplane.

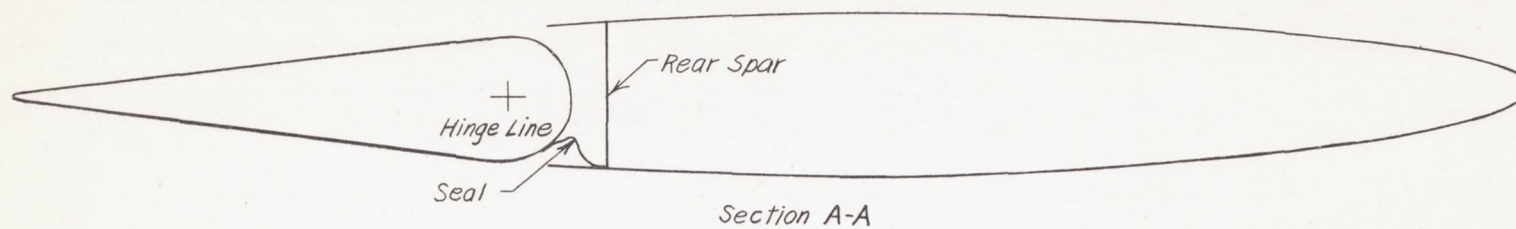
Figure 3. - Section of vertical tail, F6F-3 airplane.

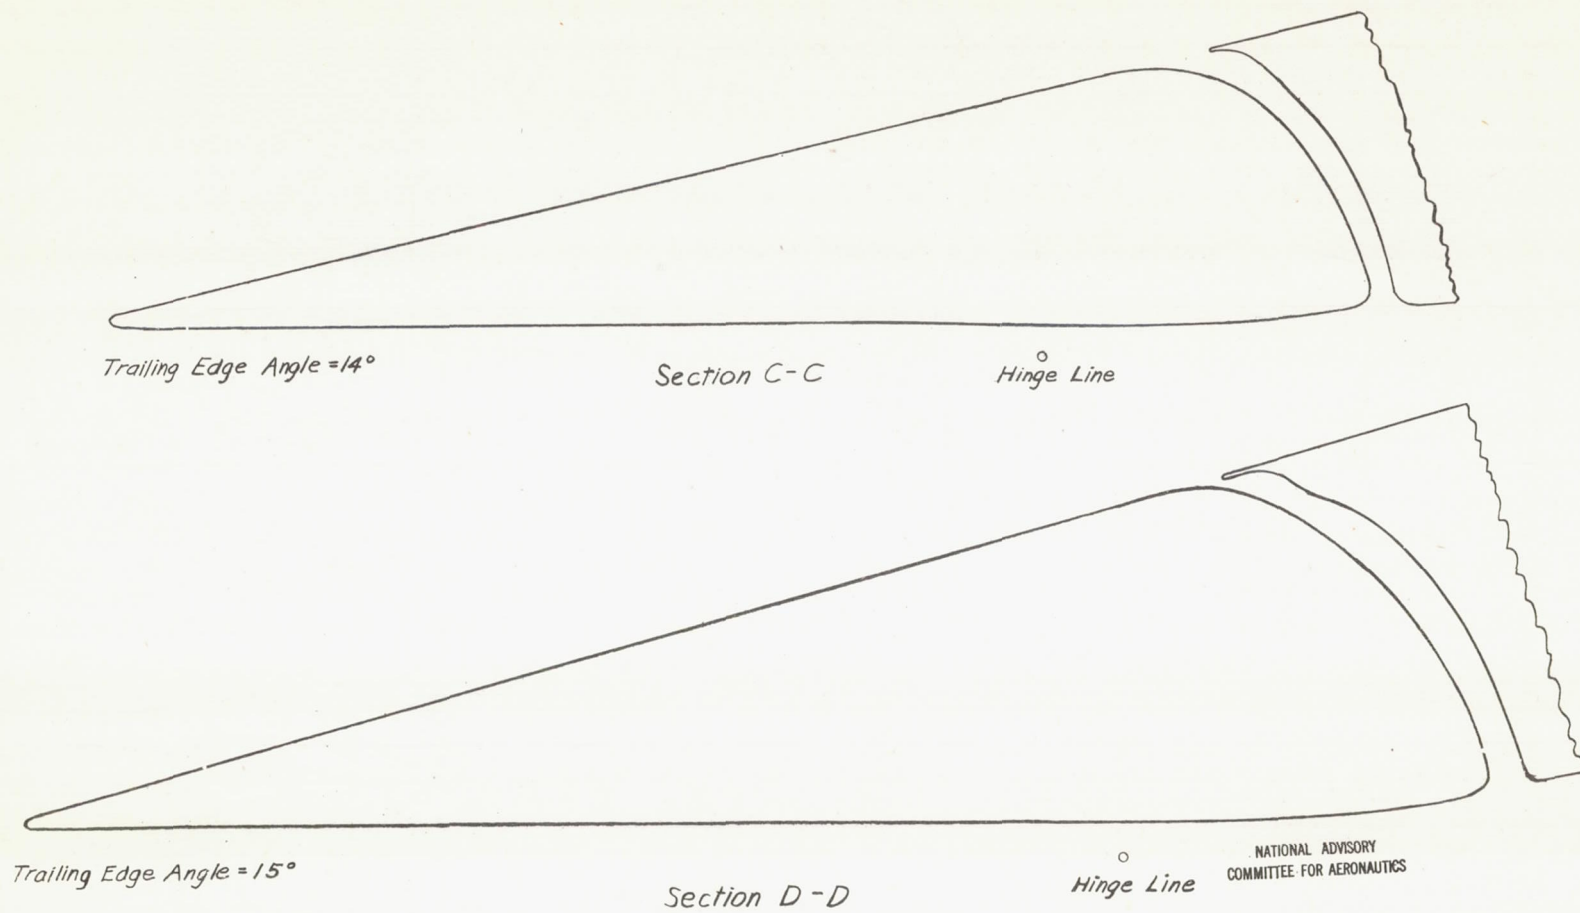
Figure 4. - Section of right aileron, F6F-3 airplane.

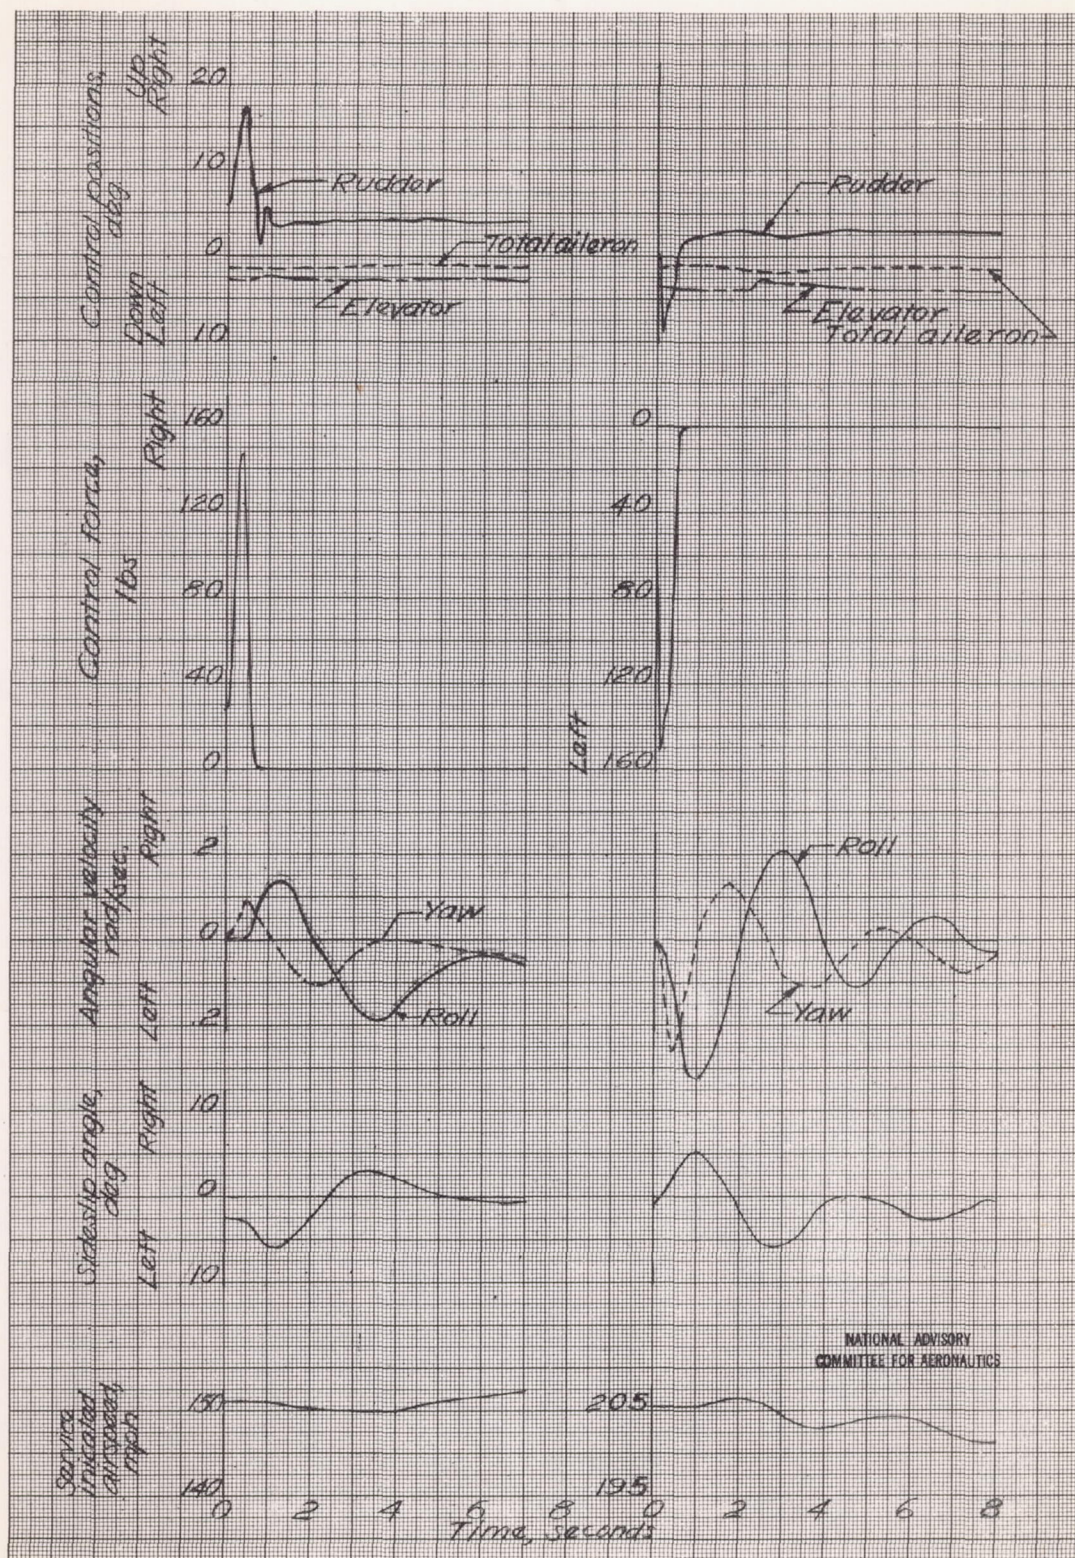
Figure 5. - Time histories of typical lateral oscillations following abrupt rudder deflection, climbing condition, F6F-3 airplane.

The characteristics of the uncontrolled lateral and directional motion were determined in the speed range from 100 to 300 miles per hour for the gliding condition and climbing condition. In these tests the airplane was trimmed for laterally level flight and continuous records were taken while the pilot abruptly deflected the rudder, then released all controls. Typical time histories of this maneuver are shown in figures 5 and 6. The variation of the period of the lateral oscillation with service indicated airspeed is shown in figure 7. It can be seen, on figures 5 and 6, that the short-period lateral oscillations damped to half amplitude within two cycles, satisfying the requirements. Figure 6, however, shows that a lateral oscillation of small amplitude continued and was poorly damped. This oscillation was noticed by the pilots and was considered objectionable.

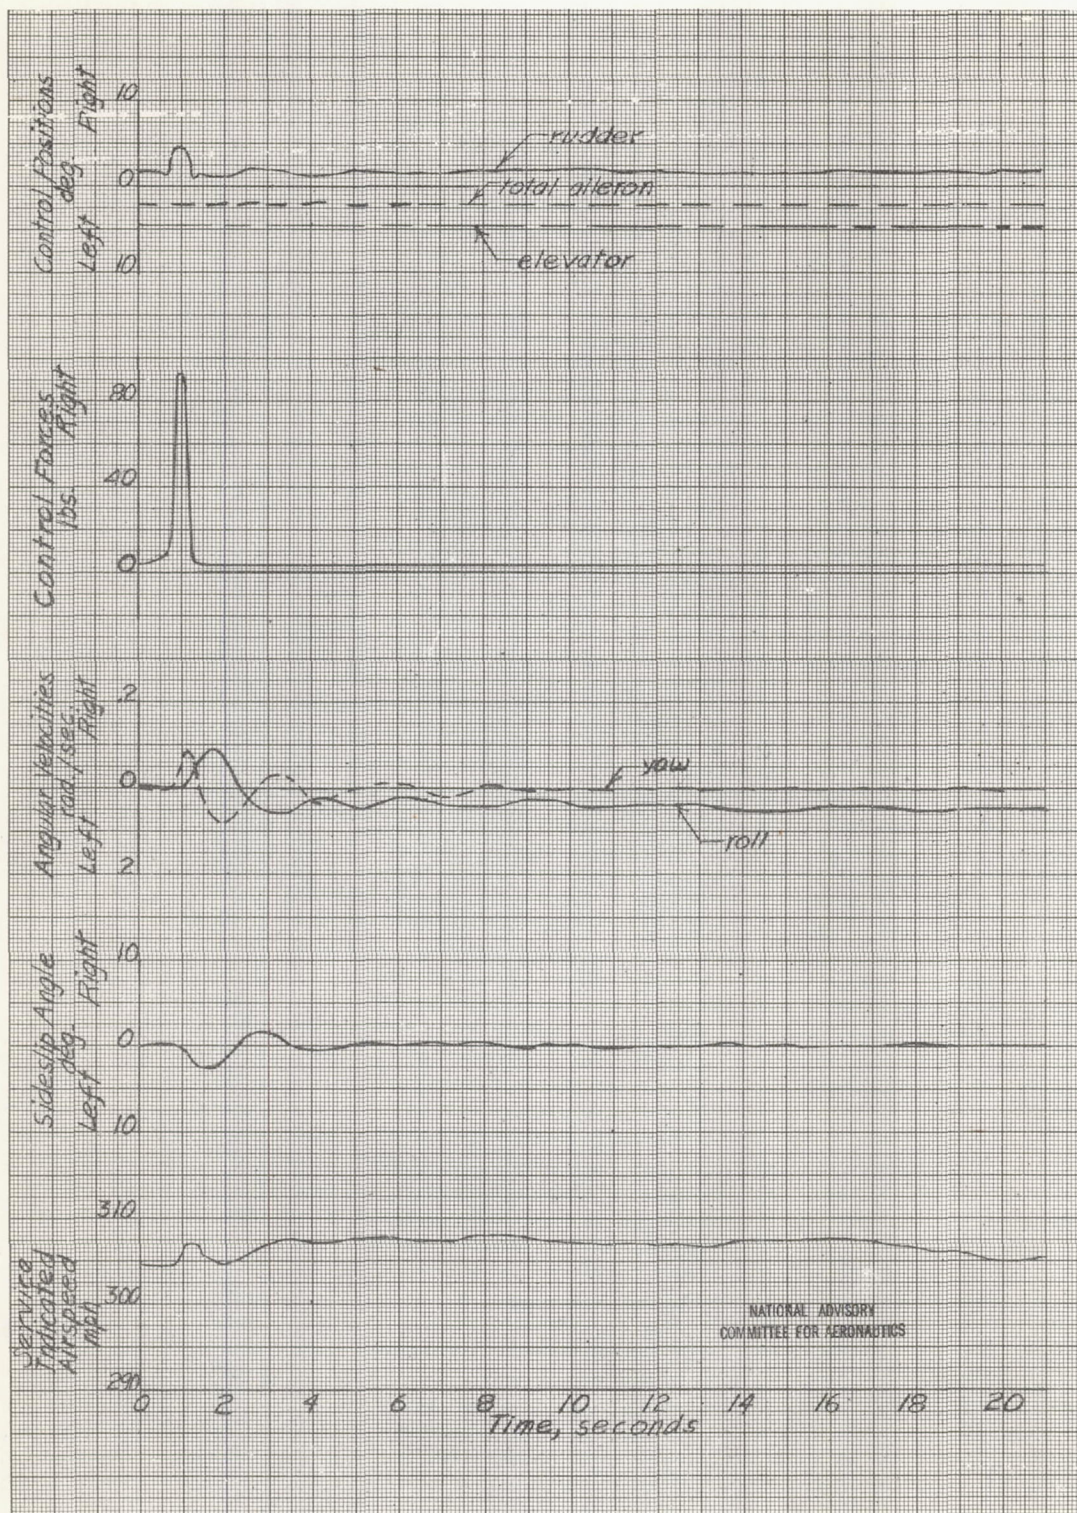
Figure 6. Time history of a typical lateral oscillation following an abrupt rudder deflection at approximately 305 miles per hour, climbing condition, F6F-3 airplane.

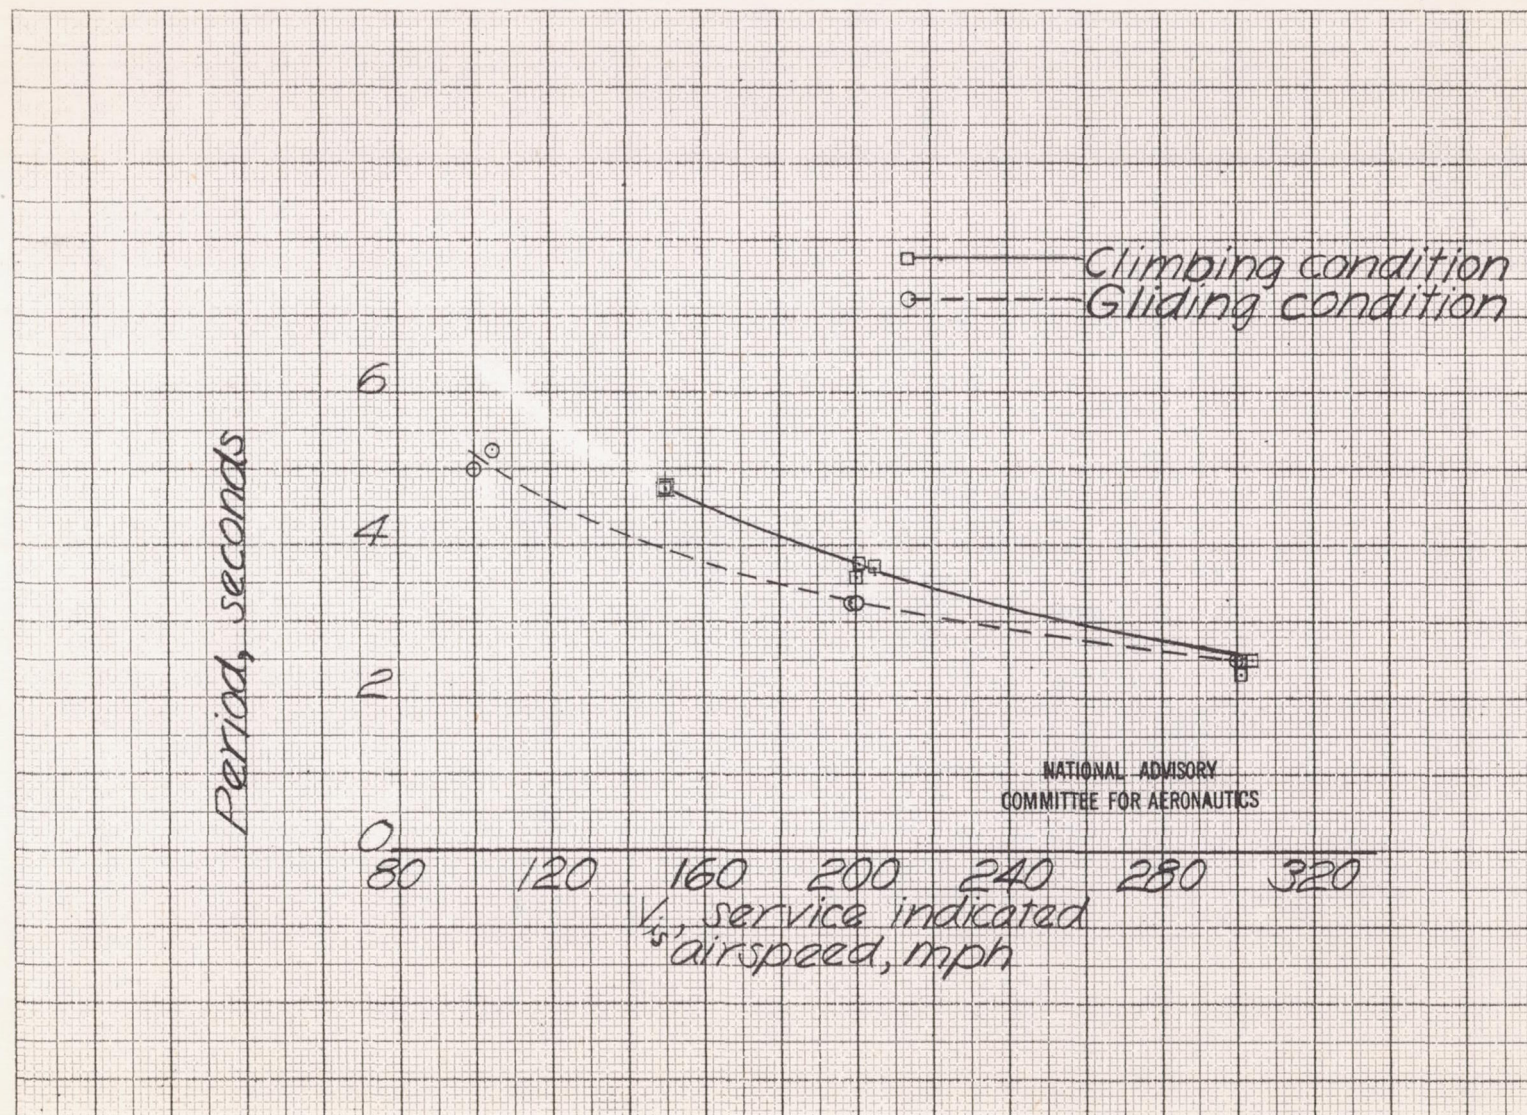
Figure 7. - Variation of the period of lateral oscillations with service indicated airspeed, F6F-3 airplane.

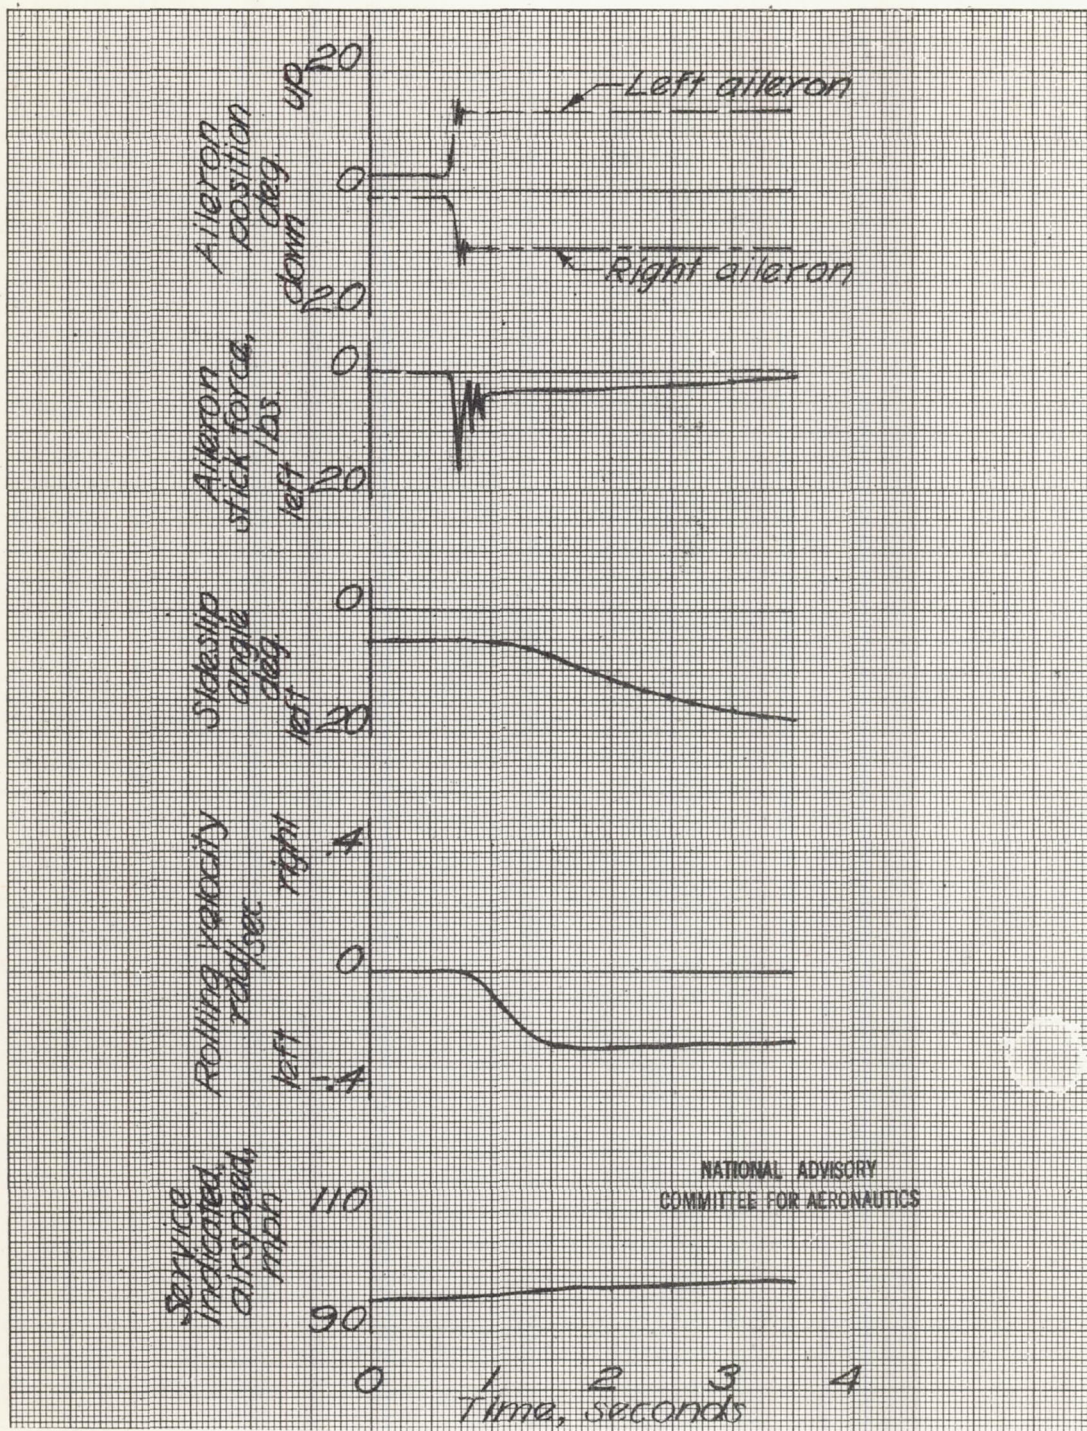
Figure 8. - Typical time history of an abrupt aileron roll made at approximately 95 miles per hour using partial aileron deflection, rudder fixed, clean condition, power for level flight, F6F-3 airplane.

Figures 8 and 9 give time histories of typical aileron rolls made from laterally level flight. It should be noted that where the use of full aileron deflection is indicated, as in figure 9, the aileron stick force shown is not a true measure of the force required to deflect the ailerons as the stick is against the stops. The data obtained from the aileron rolls were evaluated to determine the variation of aileron effectiveness $pb/2V$ and change in aileron stick force with change in total aileron angle. These data are presented on figure 10. From these data, it was possible to determine the helix angle, $pb/2V$, and

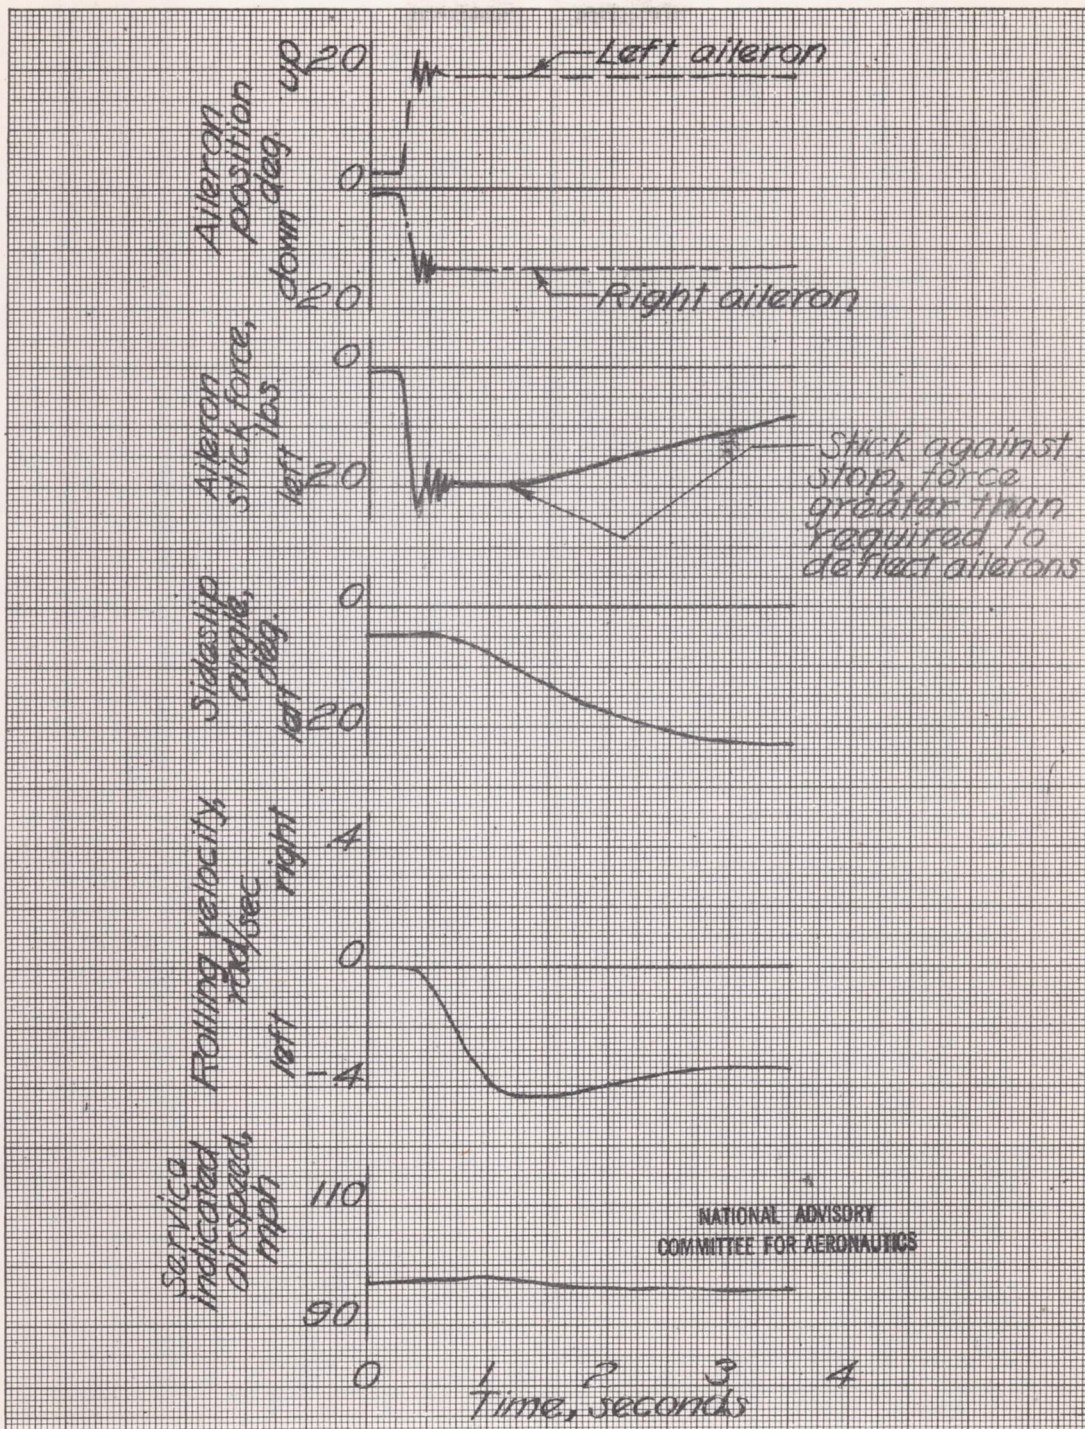
Figure 9. - Typical time history of an abrupt aileron roll made at approximately 97 miles per hour, using full aileron deflection. Clean condition, power for level flight, F6F-3 airplane.

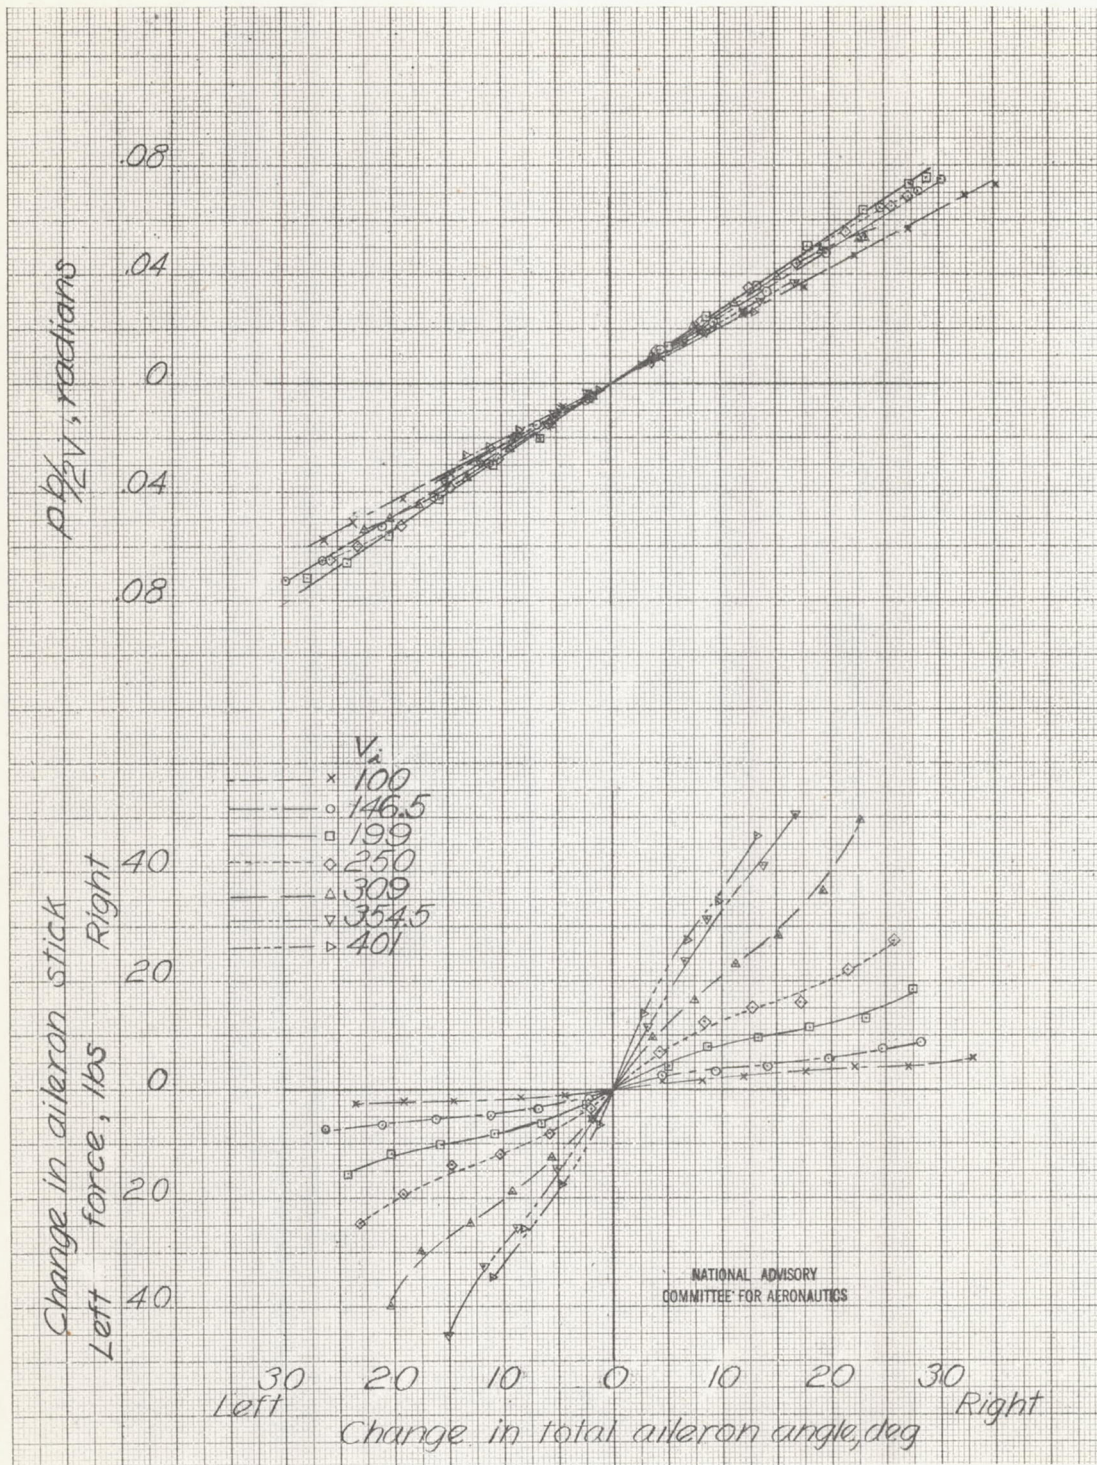
Figure 10. - Variation of the helix angle $pb/2V$ and change in aileron stick force with change in total aileron angle at various speeds, F6F-3 airplane.

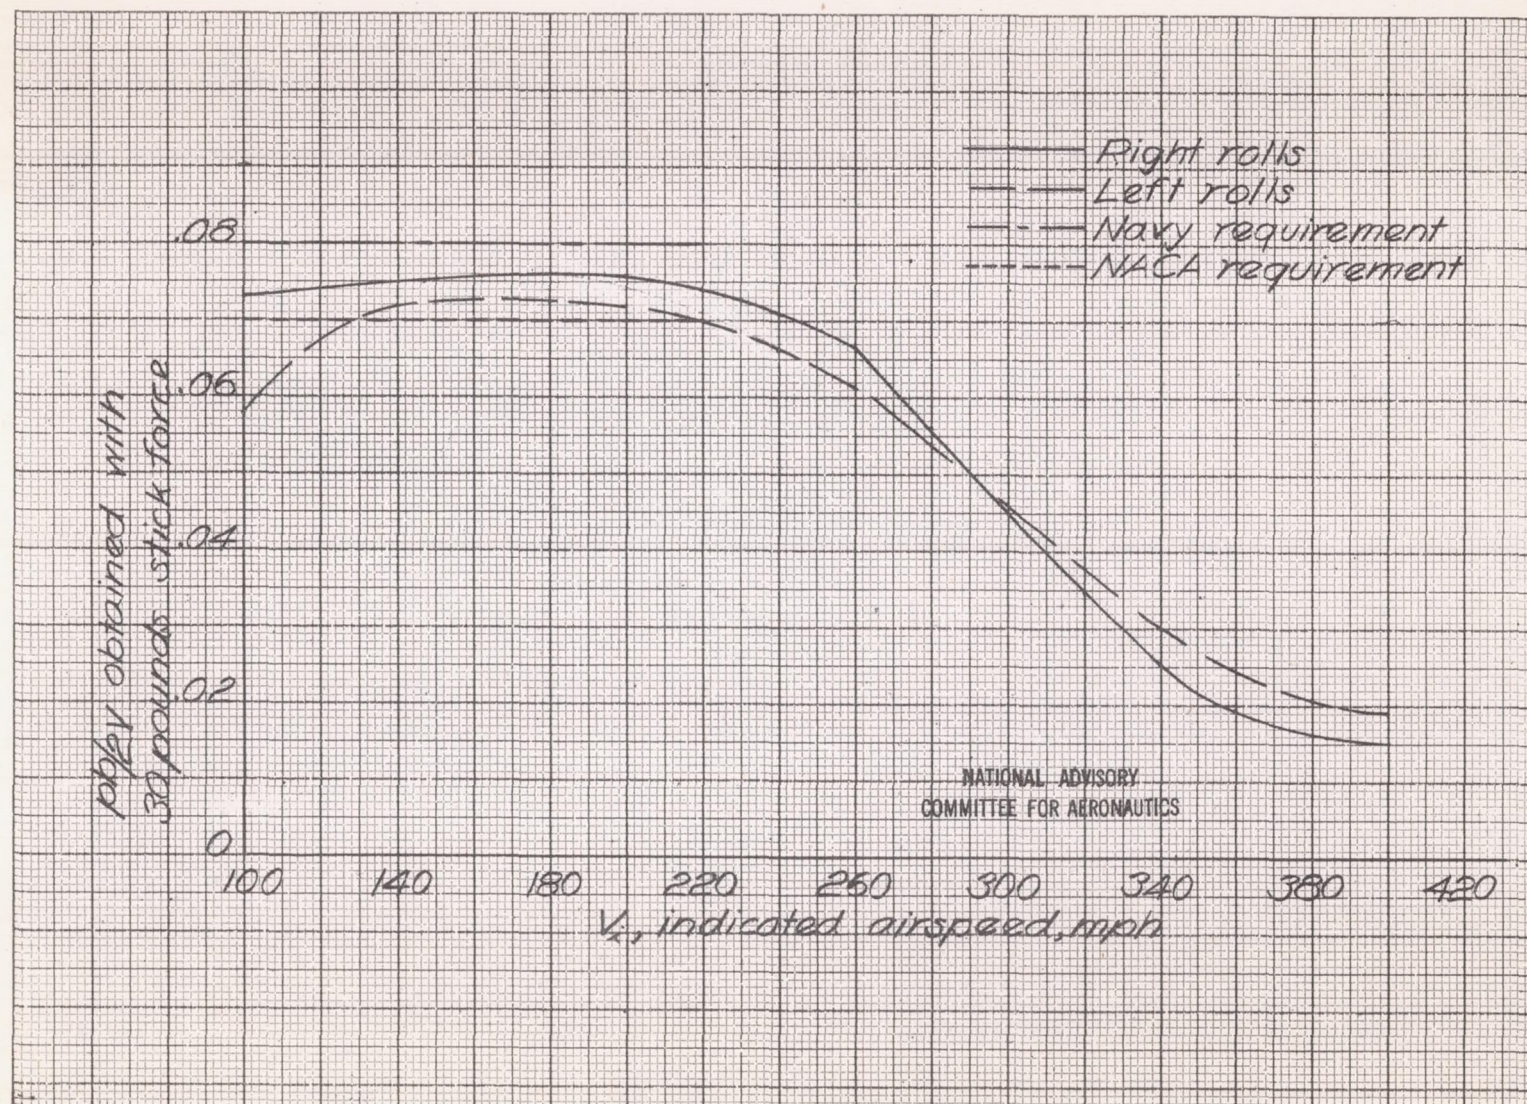
Figure 11. - Variation with indicated airspeed of the $\frac{pb}{2V}$ obtained with a 30-pound stick-force limit F6F-3 airplane.

rolling velocity obtainable with any stick force through the speed range of the tests. Figure 11 gives the values of $pb/2V$ obtainable with a 30-pound stick force as a function of speed. The Navy and NACA requirements of values of $pb/2V$ of 0.08 and 0.07, respectively, up to 80 percent of the maximum level-flight indicated airspeed (reference 2 and 3) are also shown on this figure. Figure 12 shows the rolling velocity obtained at 10,000 feet altitude with a 30-pound stick force through the speed range. The Navy requirement of a rolling velocity of 30° per second at 400 miles per hour indicated airspeed is shown on this figure.

80 percent of the maximum level-flight speed except in rolls to the left below 130 miles per hour. (See fig. 11.)

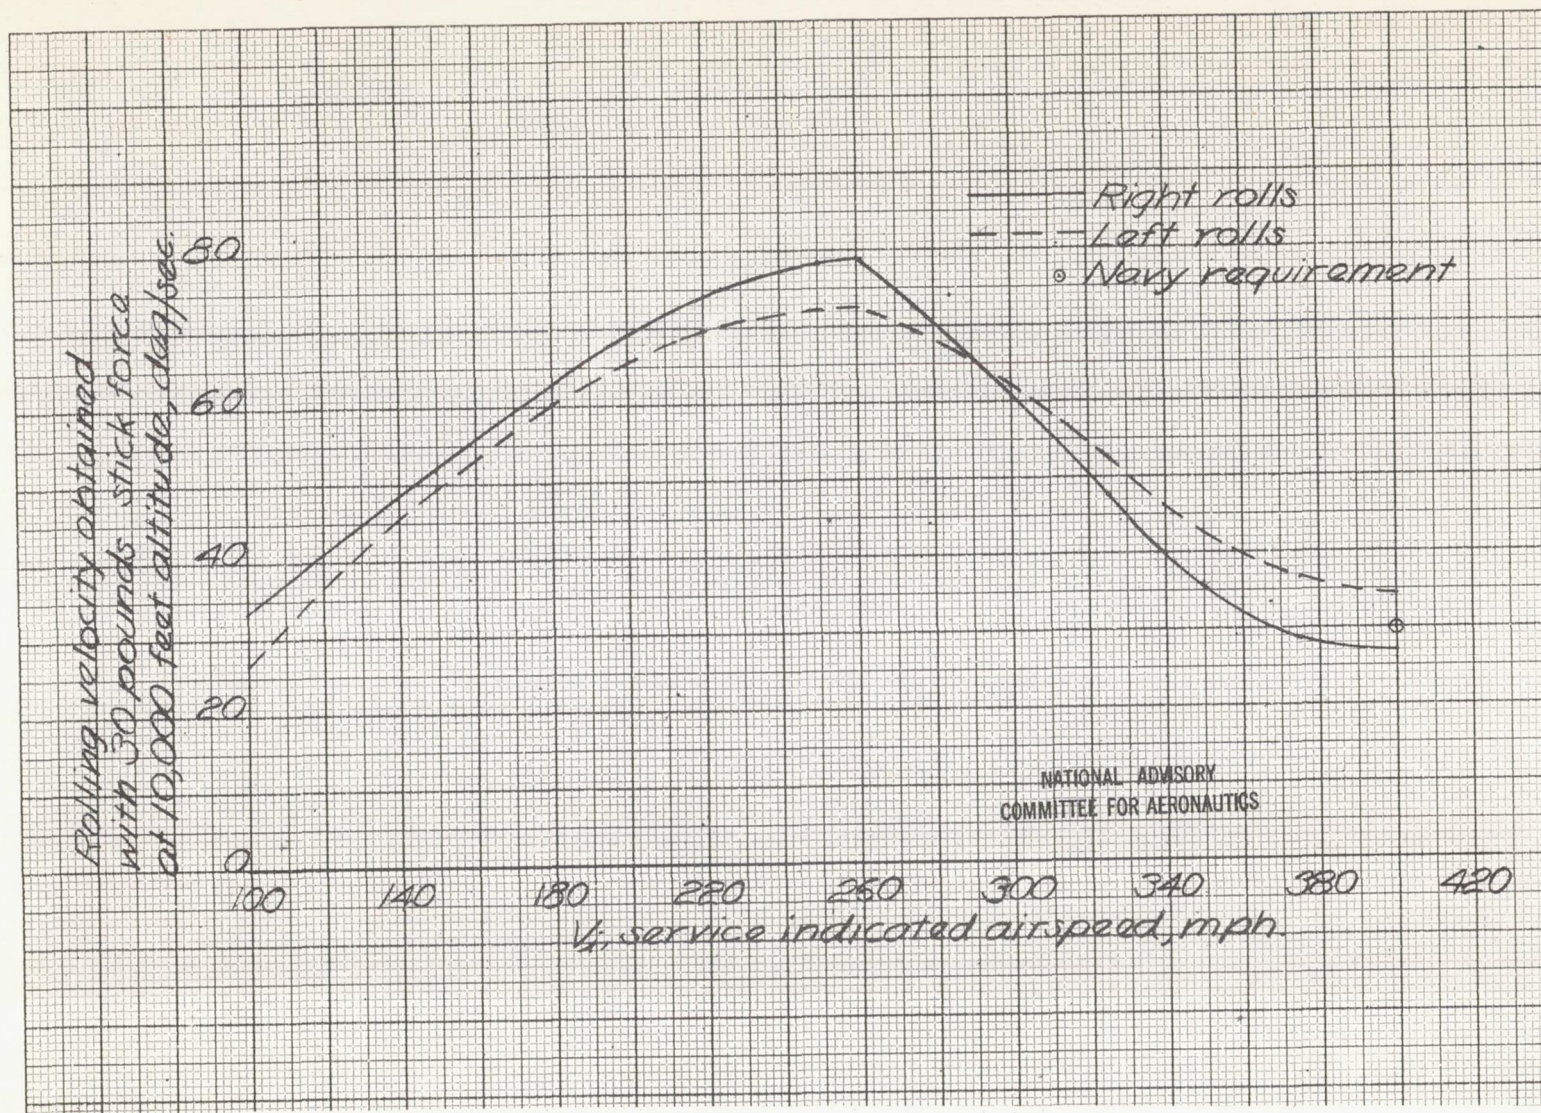
Figure 12. - Variation with indicated airspeed of the rolling velocity obtained at 10,000 feet altitude with a 30-pound stick-force limit, F6F-3 airplane.

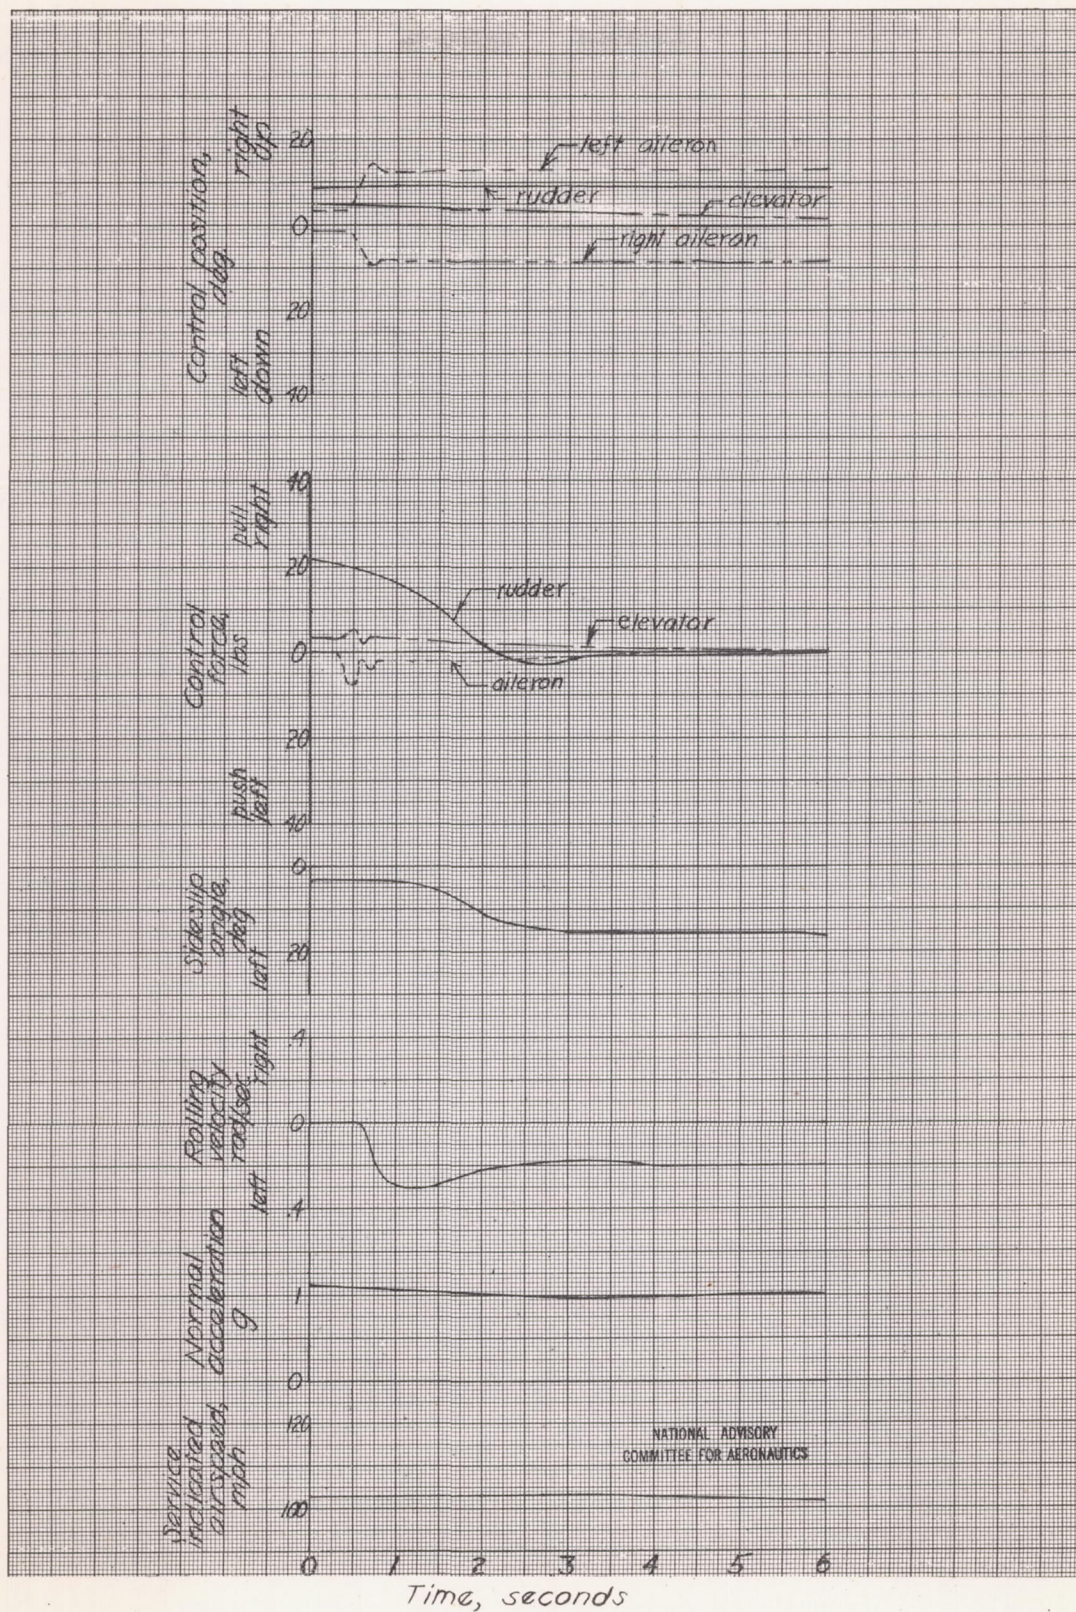
Figure 13.- Time history of rolling out of a right turn using partial aileron deflection with rudder held fixed. Clean condition, power for level flight, F6F-3 airplane.

The sideslip due to ailerons was measured in the abrupt aileron rolls from laterally level flight described above and in abrupt rolls out of turns with the rudder held fixed. The latter maneuver has been adopted as standard practice at Langley for measuring sideslip due to ailerons because it has been found difficult to obtain maximum sideslip angle in a roll from laterally level flight, since the airplane usually reaches an extreme angle of bank before maximum sideslip angle is reached. In the present instance, it was possible to reach maximum sideslip angle in right rolls from laterally level flight. Figures 8 and 9 illustrate rolls from laterally level flight. Rolls out of turns are shown in figures 13, 14, and 15. Figure 16 shows the change in maximum sideslip angle as a function of change in total aileron angle in abrupt rolls made from laterally level flight at 98 miles per hour. Inspection of these figures shows that the use of full aileron deflection at approximately 100 miles per hour will result in approximately 18.5° of sideslip.
